FORESHORE AND CHANNEL ASSESSMENT OF SPENCERS BROOK

WATER AND RIVERS COMMISSION
REPORT NO. WRM 28
2002

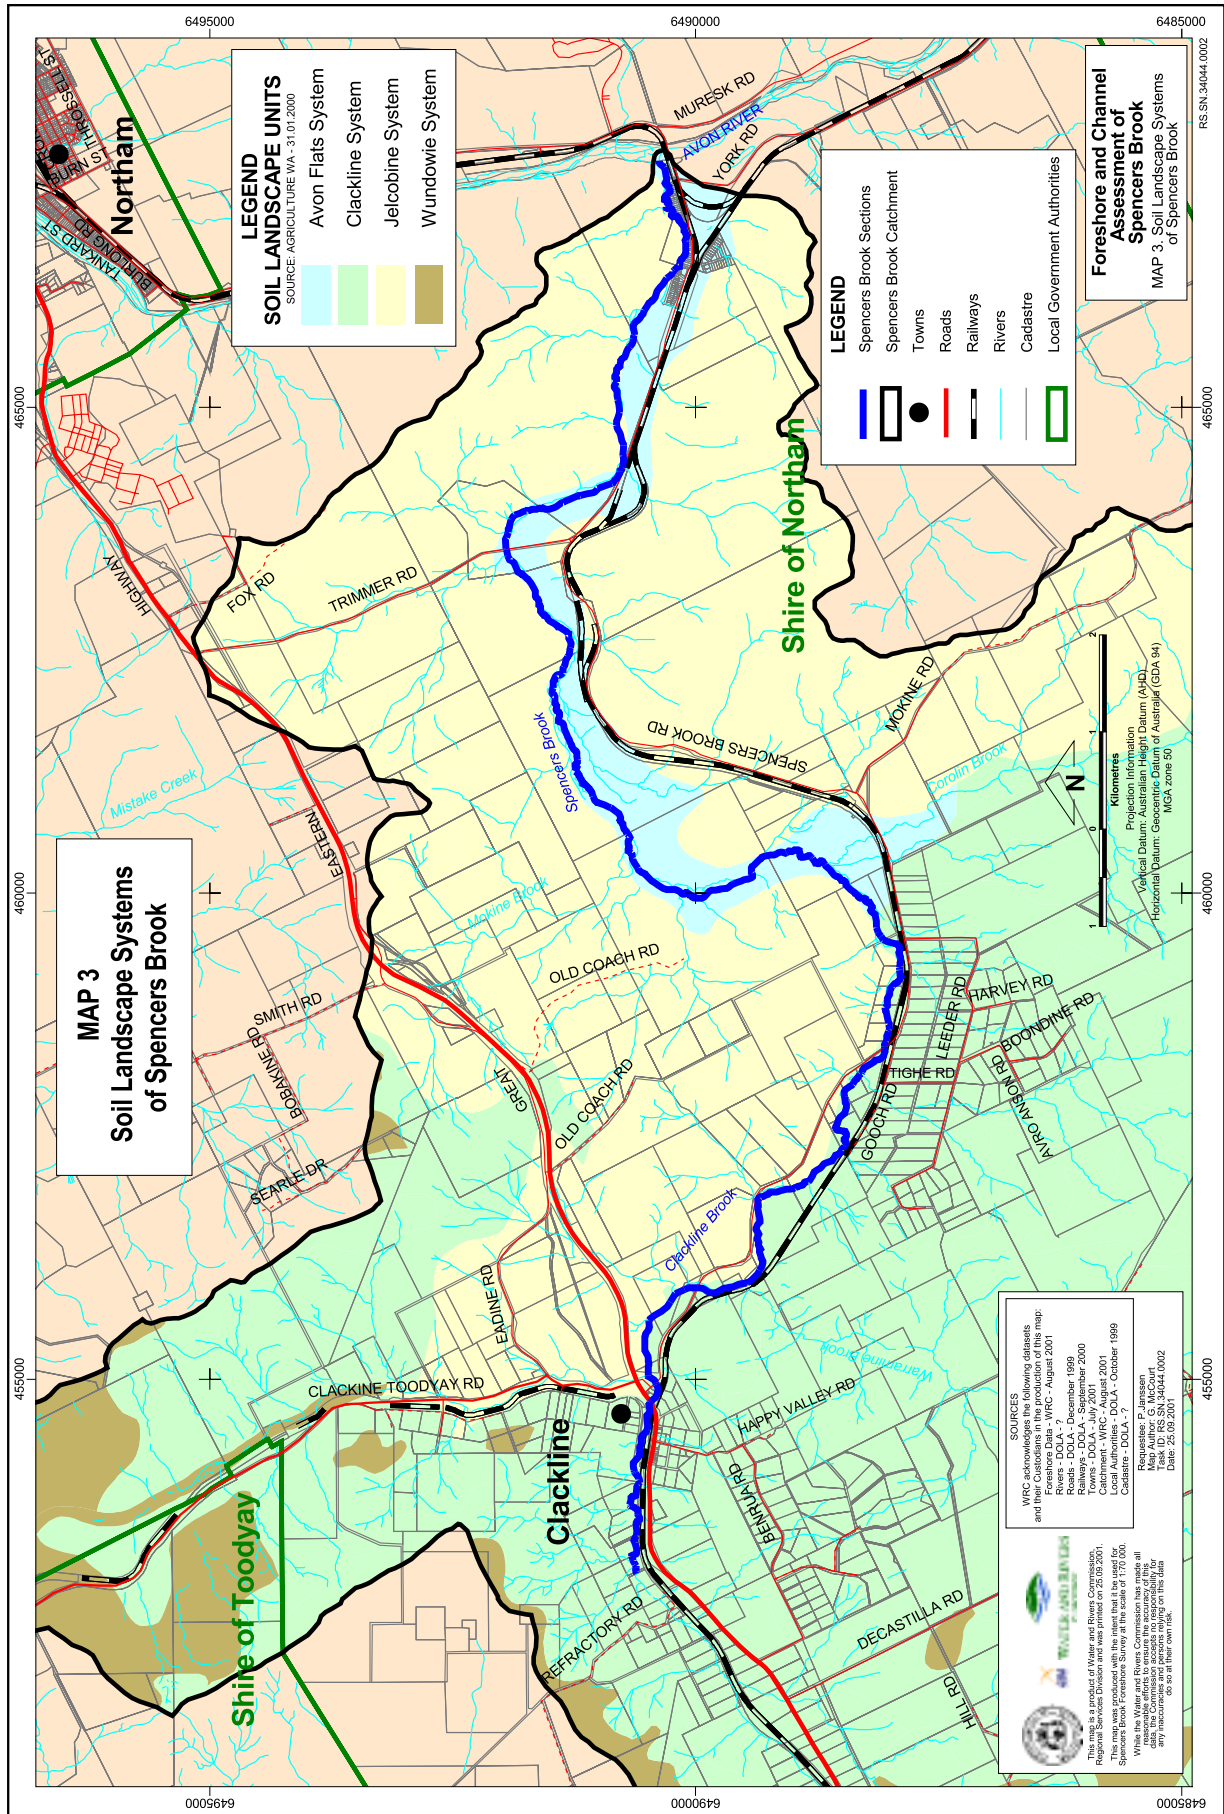
Map 3. Soil landscape systems

The Avon Flats system is characterised by brown loamy earths, grey non-cracking clays, and deep brown sands. This system is commonly found along alluvial terraces and flats (Agriculture Western Australia, 1999).

The Clackline soil system is located along the lower, mid and upper slopes of the surrounding catchment area and is characterised by shallow grey sandy duplexes, duplex sandy gravels, loamy gravels, shallow pale sands and red loamy duplexes. It is often limited to moderately dissected areas with gravelly slopes and ridges (Lantzke and Fulton, 1992).

The Jelcobine system is located on the hill slopes but is defined by deep red and shallow sandy and loamy duplexes, deep grey sandy duplexes, bare rock and cracking and non-cracking clays (Lantzke and Fulton, 1992 and Agriculture Western Australia, 1999).

The Wundowie unit is defined by deep sandy gravels, duplex sandy gravels and shallow gravels. It is found in the higher areas of the catchment where lateritic plateaus with rocky outcrops are common (Agriculture Western Australia, 1999).

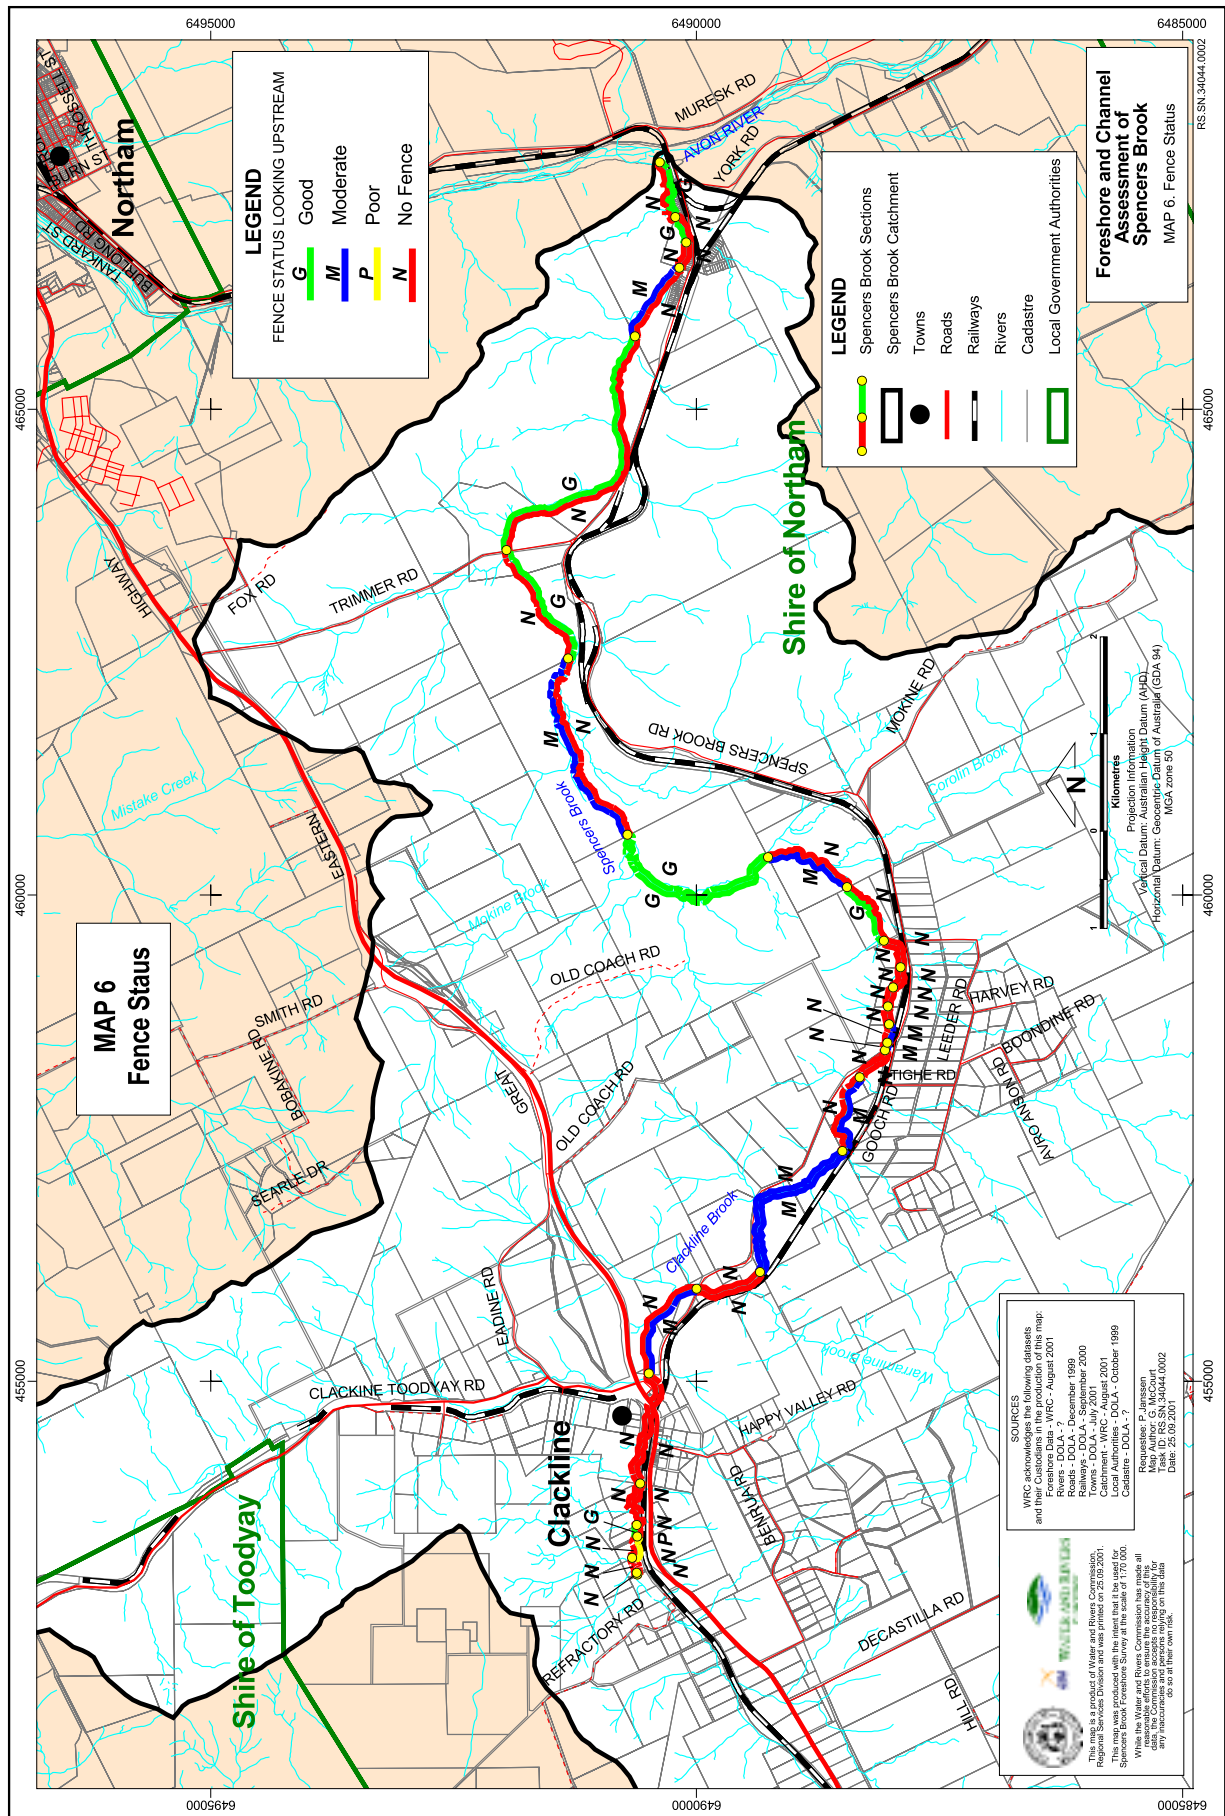
Map 6. Fence status

Of those areas that were fenced, 44% was in good condition, 50% was in moderate condition and 6% was in poor condition. Of the fencing style used along the fenced sections 12% were plain wire, 16% barbed wire, 6% electrified, 6% a combination of fabricated and electrified, 31% a combination of fabricated and barbed, 12% plain wire and electrified, and 17% plain with barbed wire. Appendix 9 provides a definition of each fencing style and examples of fence condition.

The position of the fence was also determined, with an approximation given for the distance of the fence line (left and right bank) from the bank of the waterway. Table 5 shows that the majority of fenced sections were fenced within 30 metres of the riverbank along the left bank, whereas only 11% of fenced sections along the right bank were fenced within 30m of the riverbank.

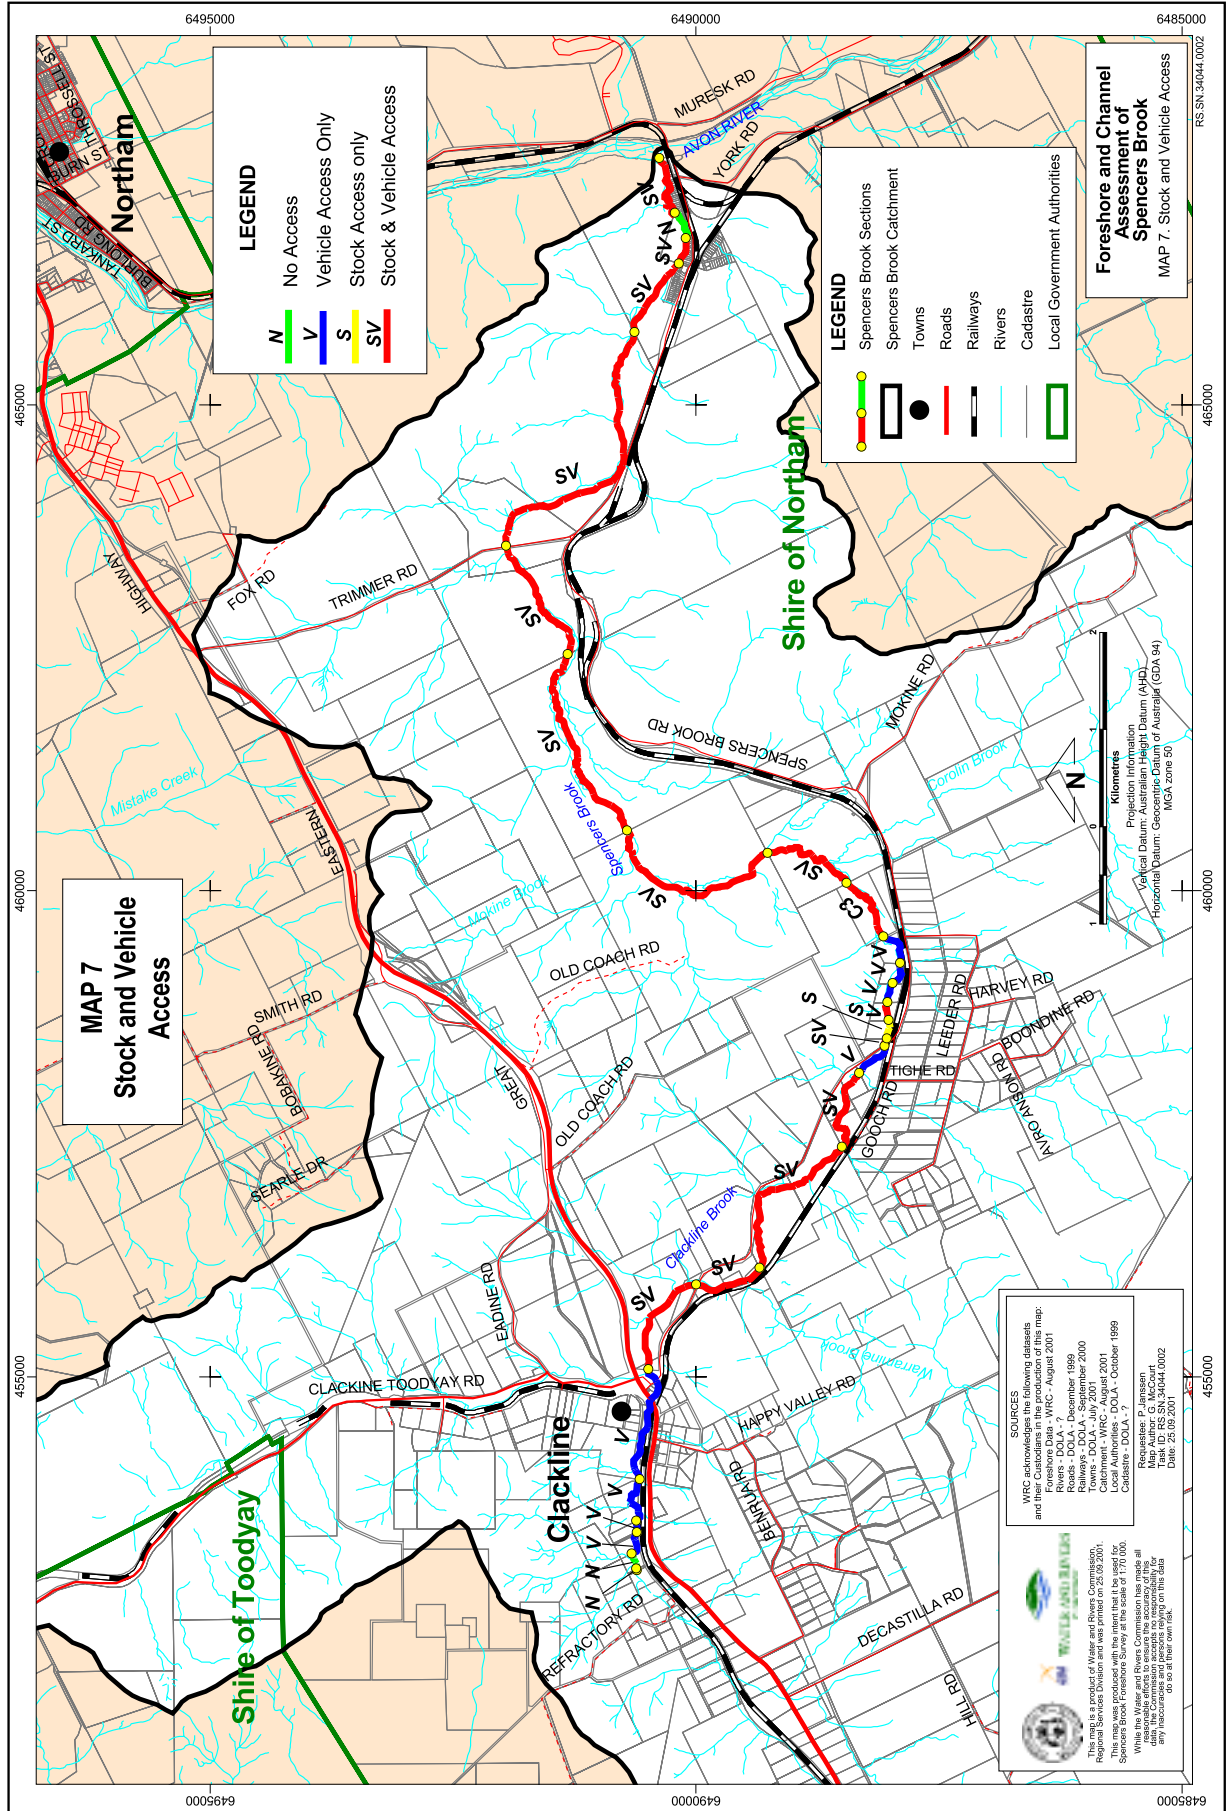
Map 7. Stock and vehicle access

Bridges and crossing points allow vehicles to pass in close proximity to the waterway, increasing the likelihood of pollution by fuel, oil and other contaminants. Poorly engineered structures can lead to problems such as increased erosive capacity and a decline in fish migration. Results indicate that service corridors (ie. roads, pipelines and powerlines) were classified as having a moderate management priority in 4% of survey sections and a low management priority in 8% of sections. Crossing points were recorded as having a high management priority in 4% of sections, moderate in 18% and low in 37% of sections.
